Technical Analysis Applied in the Inspection of Distress on the Surface of Asphalt Pavement using Remotely Piloted Aircraft (RPA)

BRT represents articulated transport that travels in an exclusive corridor and, therefore, is a faster travel alternative for passengers. In the city of Rio de Janeiro, the BRT was inaugurated in June 2012, with the TransOeste corridor, connecting the neighborhoods of Santa Cruz and Barra da Tijuca. The system also has two other corridors: TransCarioca and TransOlimpica, opened, respectively, in 2014 and 2016 (Figure 2). The place where the study was carried out is a section of the BRT Transoeste corridor in Rio de Janeiro, which connects the Barra da Tijuca to Santa Cruz and Campo Grande, passing through Guaratiba and Recreio dos Bandeirantes. Within this corridor, the study area in question is the connection between Pontal station, to Dom Bosco station, which corresponds to a strip approximately 750m long, indicated by the red fill yellow rectangle below.

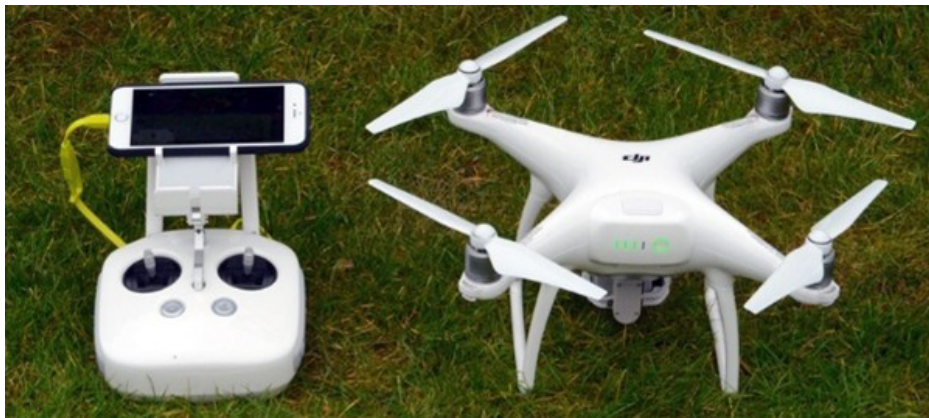
Figure 3 RPA equipment used.

For the images acquisition, the RPA Phantom 4 Pro from the DJI brand, owned by one of the authors of the article, was used (Figure 3). The aircraft is equipped with a 20-megapixel 1-inch sensor capable of recording 4K video. Additionally, its Flight Autonomy system includes two rear vision sensors and infrared detection systems for a total of 5 obstacle detection directions and 4 obstacle avoidance directions. Along with the radio control, a smartphone was used that connects to the radio control via Bluetooth technology to upload data. This device was used to upload flight plans and monitor the BRT Transoeste mapping process. The PIX4D Capture software was used for flight planning and for monitoring during the Phantom 4 Pro flight, the application used was DJI GO 4.

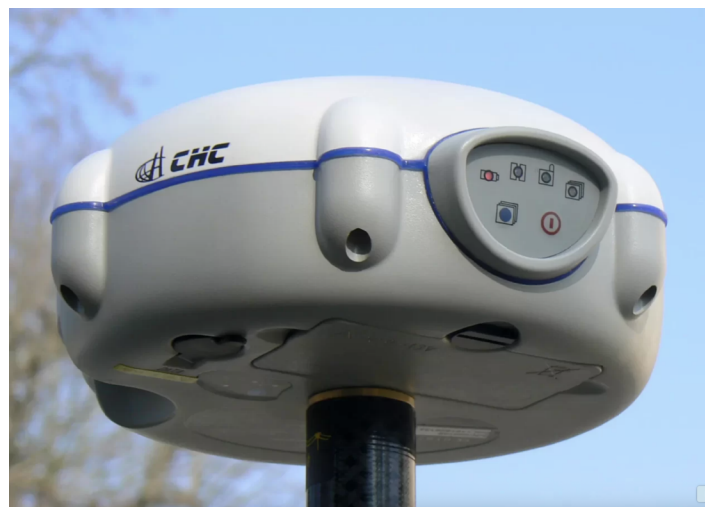
Figure 5 GNSS receiver used.

To collect the mapping control points, a CHC brand GNSS X900U+ receiver was used (Figure 5), it is a Post-Processed GNSS with 432 channels and the possibility of correction via RTK NTRIP (CHC 2023)

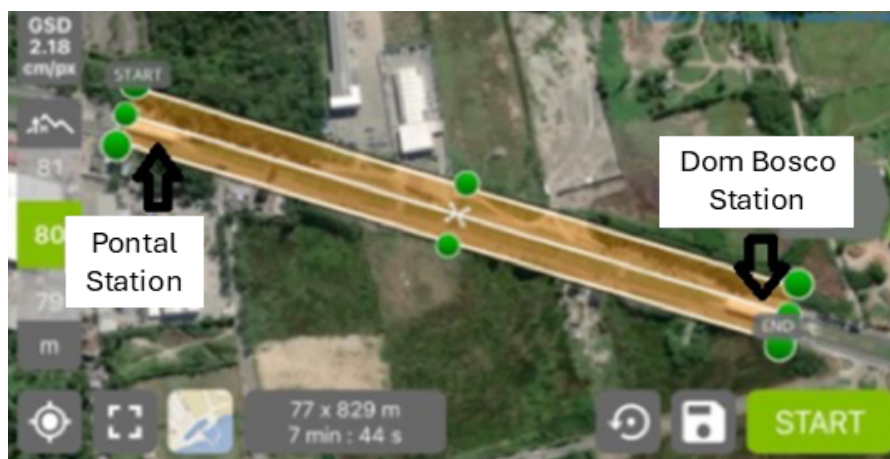
Figure 6 Flight planning.

A corridor mapping is characterized by a long, narrow area. This type of technique is very common, especially on highways. The chosen flight direction was Southeast – Northwest, precisely so that the flight range would be longer, making the RPA gain battery autonomy throughout the flight. In total, three flight lanes were needed to cover the BRT Transoeste area between Pontal and Dom Bosco stations, as shown in Figure 6.

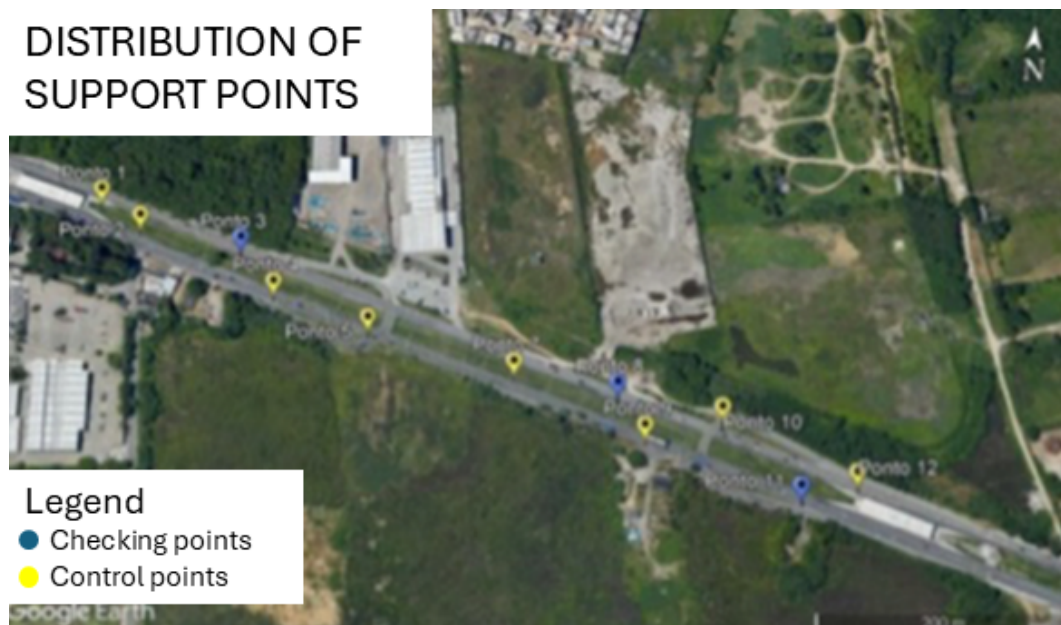
Figure 7 Distribution of support points.

However, it is worth checking to what extent it is economically viable to install so many control points. In this work, 12 support points were collected within the area of interest, as shown in Figure 7, to support the RPAs survey. These points were raised using the RTK NTRIP technique. It should be noted that 1 point was removed from the survey due to a high positional error. Finally, the distribution was as follows:

- 8 points were used as control points;
- 3 points were used for checking.

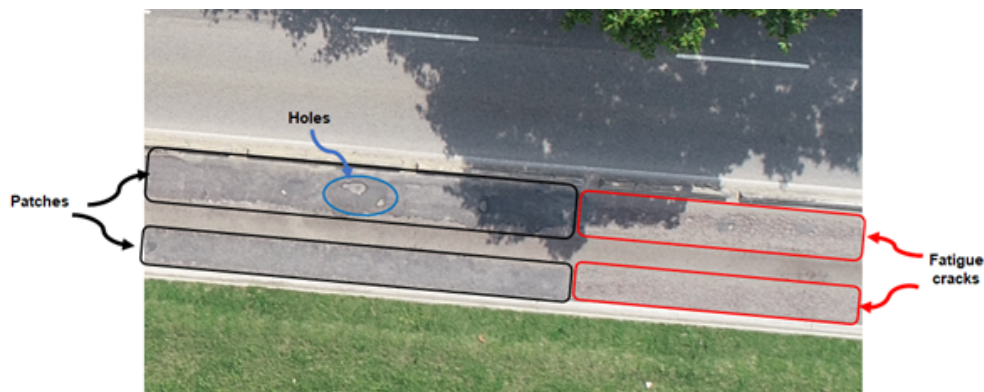
Figure 12 Presence of patches, potholes, and fatigue cracking in Section 01.

From the evaluation of the images obtained by RPA, it was possible to verify that all sections had already been subjected to intervention, where the main maintenance activity was patching. However, the quality of the existing patches is very low, and in several sections the presence of potholes or pans can be observed. Furthermore, in places where interventions have not yet been carried out, high severity fatigue cracking are also present and are visible in the images produced by RPA. Figure 12 clearly shows the presence of distress (patches, potholes, and fatigue cracking) in Section 01.
